Assessment of Twenty-Eight (28) Trees  
At Sunrise Senior Living Facility, Redwood City (Proposed)  
(Multiple Residential and Commercial Lots)  
2915 El Camino Real  
Redwood City, California

Walter Levison, Consulting Arborist (WLCA)

5/5/2017

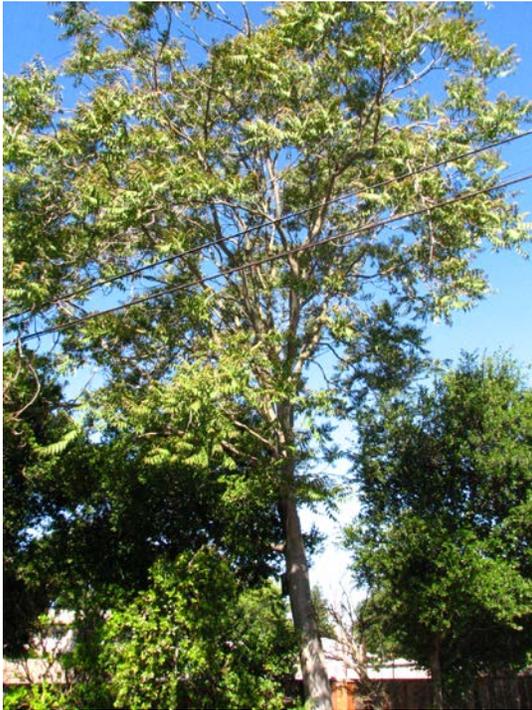
9

Tree #9 can either be retained or removed. Although the tree of heaven is typically considered a weak wooded, fast growing, short lived trash tree, specimens in good condition in terms of structure and vigor (such as this particular specimen #9) can be retained as shade trees for relatively long periods of time in the landscape. Some specimens of this species have been known to provide good site screening and shade value for many decades in and around the Bay Area peninsula area. As always, good maintenance practices are warranted, such as periodic monitoring for branch splitouts, regular irrigation application, etc.

Unlike native oak trees, the non-oaks at this site such as **tree of heaven #9** can be irrigated heavily on a regular basis (e.g. twice weekly, etc.) throughout all areas of their root zones, near to trunks and far from trunks, and will greatly benefit from such construction period temporary irrigation.

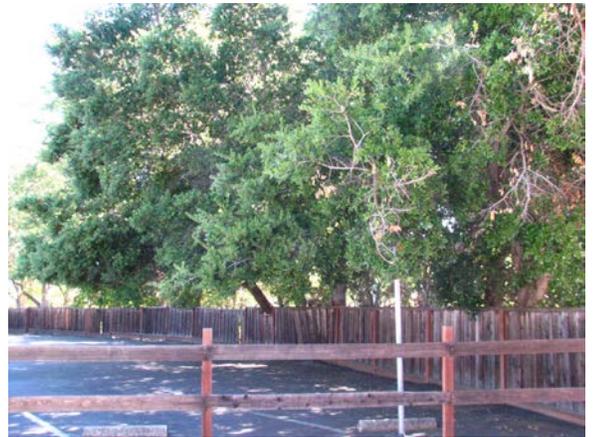
North  
view  
of  
oaks  
10, 11,  
12, 13,  
& 14  
extend  
-ed  
south  
and  
west  
into  
the (e)  
lot.

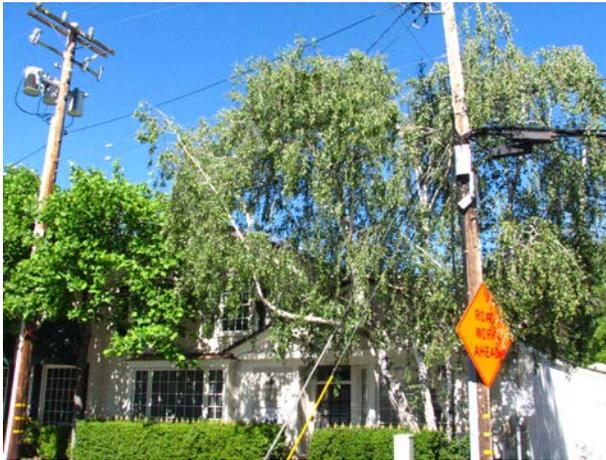
15

- c. Conflict Removals (8 trees): Trees required to be removed due to direct conflicts **include trees #15, #19, #20, #21, #22, #23, #24, and #25**.

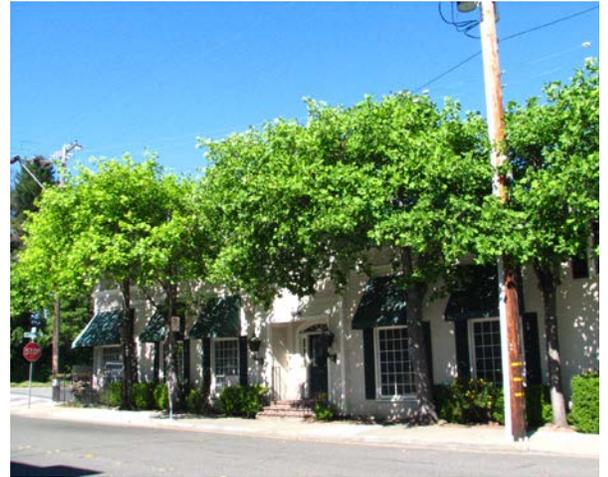
R to L  
16, 17,  
18

Trees #16, 17, and #18 are potentially retainable. However, considering the above-noted factors, it may be better to simply remove the trees and replace them with more desirable species that attain shorter ultimate heights such that the trees do not end up being pruned to clear the wires in the future. The landscape arborist of record (LAOR) on this project can be consulted to recommend appropriate replacement tree species, or WLCA can work with the LAOR to determine appropriate species.

18	tulip poplar	<i>Liriodendron tulipifera</i>	15.6	0	0	0	15.6	Yes	30/25	65/55	59% fair	mod	X					X													?	(Same as #16 above)	TB, RPZ, W if retained.
19	American elm	<i>Ulmus americana</i>	29.7	0	0	0	29.7	Yes	35/40	25/25	25% very poor	poor	X																X	X	Twig and branch dieback throughout noted. Root crown decay noted. Tree is slated for removal due to conflicts with plan.	---	
20	tree of heaven	<i>Ailanthus altissima</i>	28.1	0	0	0	28.1	Yes	35/30	20/15	18% very poor	very poor	X																X	X	Twig and branch dieback throughout noted. Root crown decay noted. Flux noted on bark. Asymmetrical root plate noted. Tree is slated for removal due to conflicts with plan.	---	
21	American elm	<i>Ulmus americana</i>	43.5	0	0	0	43.5	Yes	45/45	40/30	36% poor	poor	X					X											X	X	Tree has been limbed up many times to clear the existing Bentley's restaurant parking lot stall areas. Tree exhibits multiple codominant mainstems with bark inclusions (structural defect). Tree to be removed due to conflicts with building footprint.	---

WLCA suggests considering removal of **trees #8, 16, 17, and #18** due to poor condition and/or low species value in the landscape.

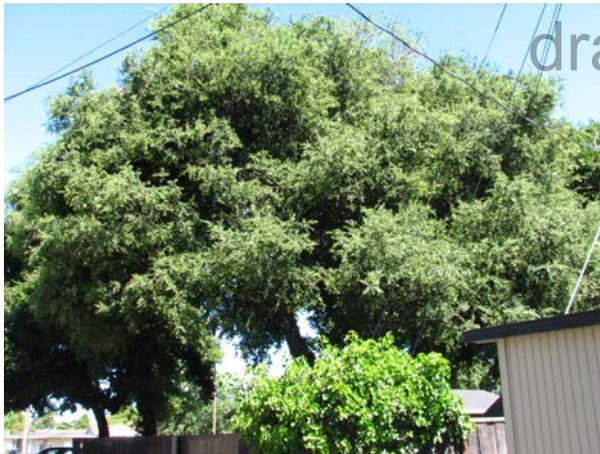
23

Construction of the current proposed driveway area that extends west of the proposed new building footprint will require removal of large diameter coast live oaks #23, 24, and #25 in good, good, and fair overall condition respectively.

**Consider installation of large size boxed trees such as 48" or 60" native coast live oak or other species at a 3:1 mitigation ratio for loss of existing oak #23, 24, and #25 canopy value (if removed). Work with City Staff to determine adequate replacement ratios, etc.**

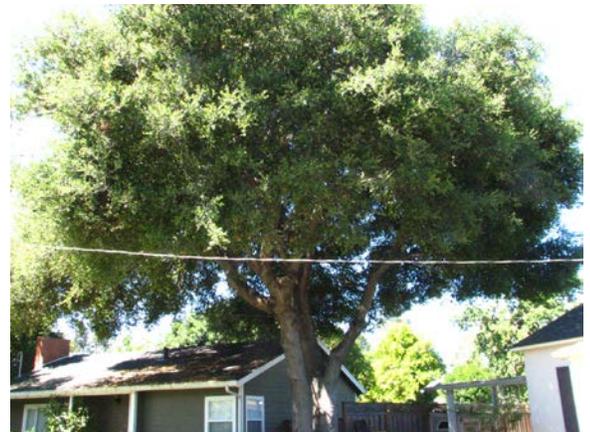
24, 25

25	coast live oak	<i>Quercus agrifolia</i>	est. 26	0	0	0	est. 26	Yes	27/30	90/40	65% fair	good					west	west												X		Tree to be removed due to proposed asphalt driveway at the west side of the site. Note: severs trunk lean off vertical to the west.	---
26	California valley oak	<i>Quercus lobata</i>	est. 30	0	0	0	est. 30	Yes	35/35	75/85	70% good	mod																				Tree is shown on the conceptual site plan sheet A1.0 to be retained at the northwest corner of the merged lot area. Tree was not fully assessed due to lack of access to the lower trunk. Assume "good" overall condition rating.	TB, RPZ, and maintain offsets of at least 30 feet between trunk and nearest trenching for irrigation, utilities, drainage.
27	coast live oak	<i>Quercus agrifolia</i>	30.5	0	0	0	30.5	Yes	50/50	90/70	80% good	good					south west														Note root extension to south may be severely limited due to presence of existing house foundation 4 or 5 feet south of trunk, but this cannot be verified. Current proposed utility trenching appears far enough offset to south that it will not interfere with the root system of this tree.	TB, RPZ, and maintain offsets of at least 15 to 20 feet between trunk and nearest trenching for irrigation, utilities, drainage.  Do not renovate driveway to the north of trunk, as this could cause severe root loss and death of the tree.

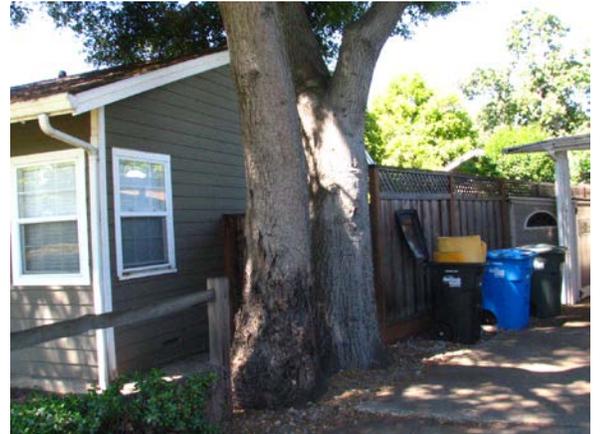
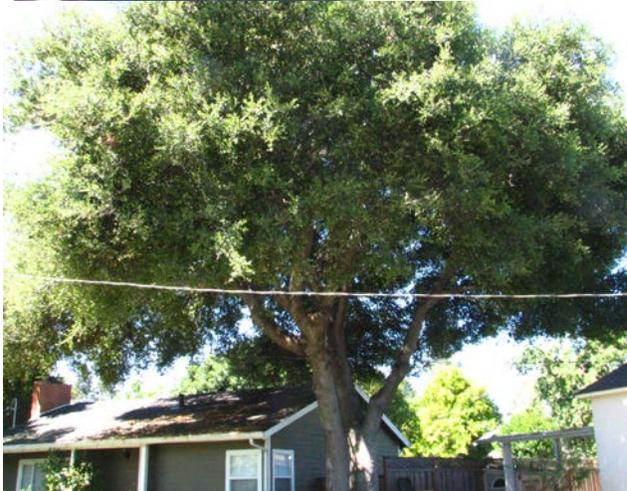
R to L  
27, 28

28	coast live oak	<i>Quercus agrifolia</i>	30.3	0	0	0	30.3	Yes	30/30	75/80	67% fair	good	X		X		south east														Sycamore bark moth larvae feeding causing severe wood tissue necrosis in lower trunk area.  Root expansion causing severe displacement of the existing driveway to north (neighbor property).  As noted above, root extension to south is limited due to existing house to be demolished. However, WLCA still recommends keeping all utilities offset from trunk at least 15 to 20 feet.	TB, RPZ, and maintain offsets of at least 15 to 20 feet between trunk and nearest trenching for irrigation, utilities, drainage.  Do not renovate driveway to the north of trunk, as this could cause severe root loss and death of the tree.	
<p><b>Notes:</b></p> <p>1. On-site survey trees include all existing specimens of tree species with at least one (1) mainstem measuring greater than or equal to 12.1 inches diameter when measured at between 6 inches and 36 inches above mean grade.</p> <p>2. Various trees in this study were located behind locked private property gates, and were therefore assessed from afar without access to the lower trunks. These trees are noted with trunk diameters of "estimated" in the table above.</p> <p>3. Heights measured using a Nikon 550 Forestry Pro. Diameters were measured at between Redwood City standard height of between six and thirty-six inches above mean grade using a forestry D-tape that converts circumference to an average diameter. Canopy spread is noted in visually estimated feet (shown with both height and spread data for each tree in a single cell).</p> <p>4. Locations of the trees are shown on a tree plot sheet provided by Sunrise, marked up by WLCA.</p>

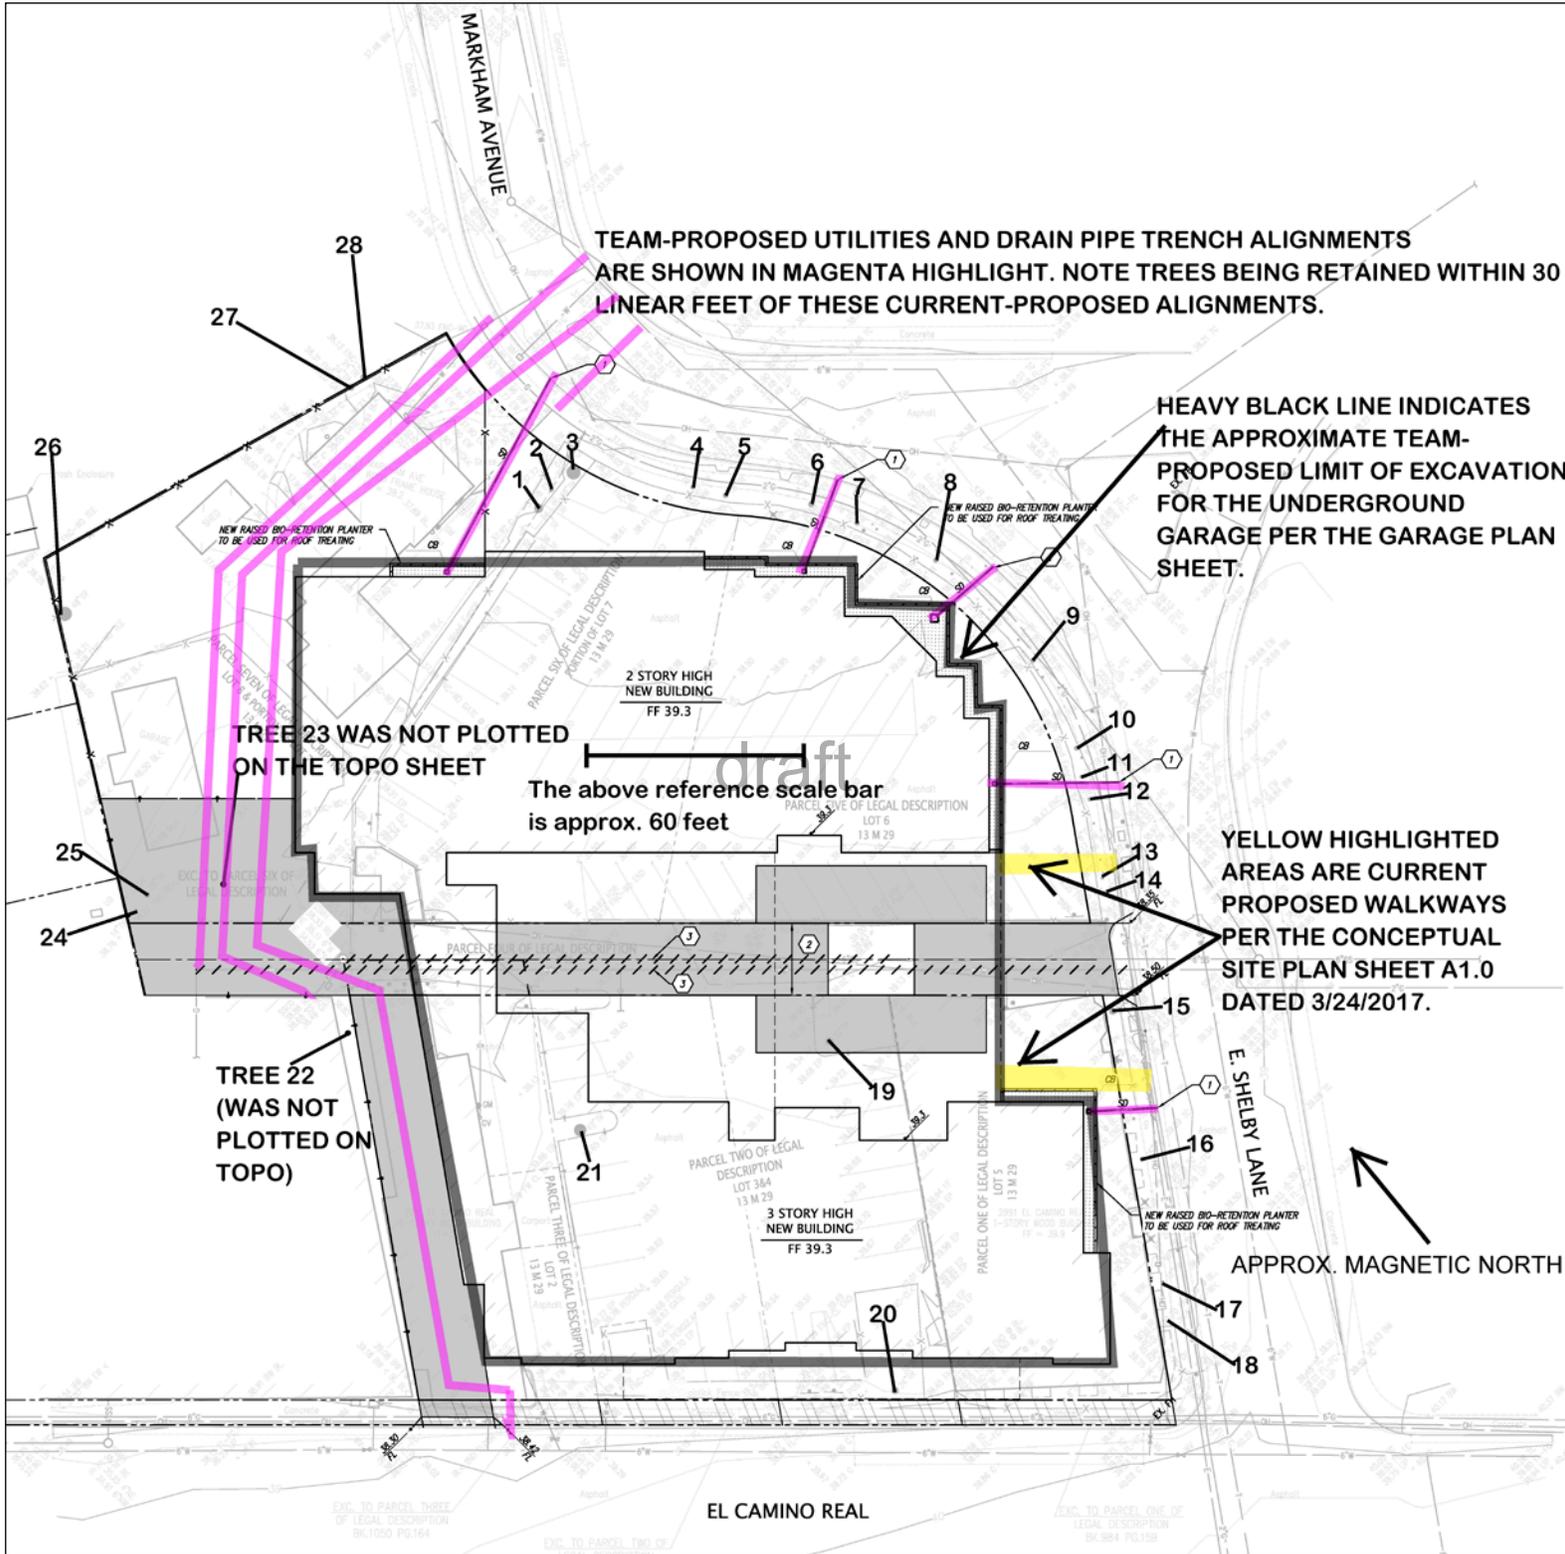
## 10.0 Tree Location Map Mark-Up (WLCA)

Black heavy lines outline the limit of current-proposed underground garage excavation, which coincides with the proposed building foundation footprint.

WLCA assumes that these proposed utility, drainage, and walkway items can be adjusted as necessary to avoid destroying the root systems of important trees being retained, such as native oaks in good overall condition (see the Excel tree data charts for more details in individual trees).
