**COUNTY OF SAN MATEO  
PLANNING AND BUILDING DEPARTMENT**

**SUBJECT:** EXECUTIVE SUMMARY: Consideration of a Coastal Development Permit, pursuant to Section 6328.4 of the County Zoning Regulations, to expand the parking lot at Quarry Park facility in the unincorporated El Granada area of San Mateo County. This project is appealable to the California Coastal Commission.

County File Number: PLN2022-00132 (San Mateo County Parks Department)

# Quarry Park Pump Track Parking Lot Extension

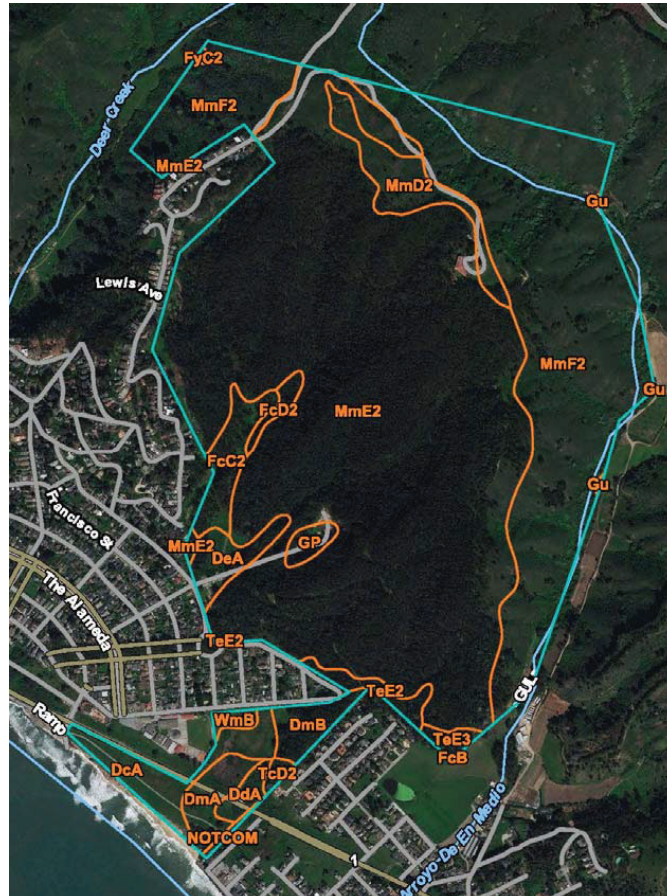
K factors for the Universal Soil Loss Equation (USLE) determined by the National Cooperative Soil Survey (USDA NRCS, 2013) range from 0.15 for the Miramar complex soils to 0.32 for the Tierra complex soils. The higher K factors indicate more potential for erosion.

**Figure 1.** Soils within Quarry Park Property according to NRCS Websoil Survey.

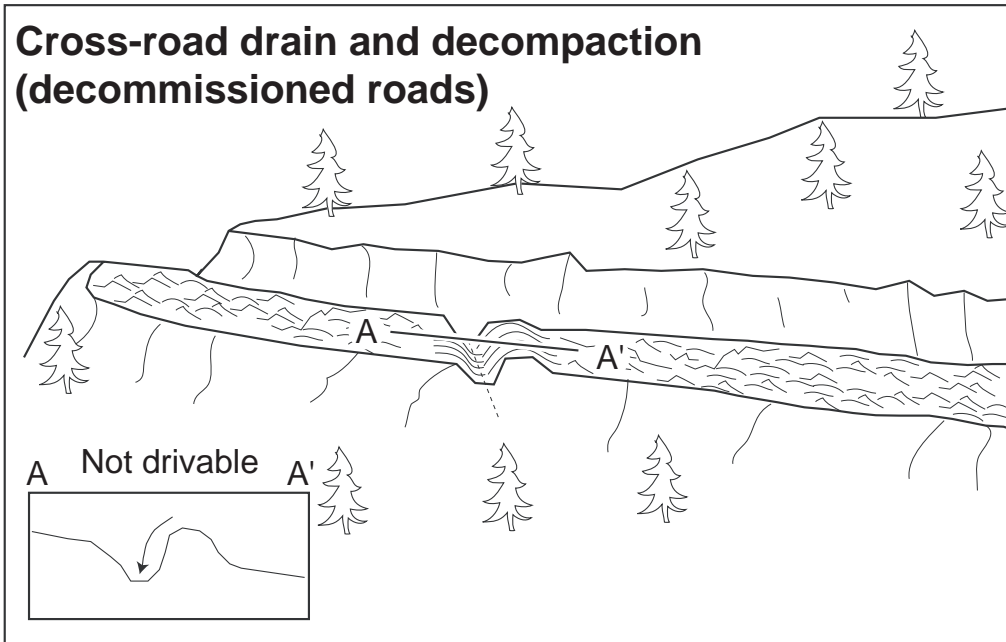
**Typical Drawing #16**

*Cross road drain* construction will ensure gullies, springs, road runoff and other concentrated flow will no longer collect over long lengths of road causing gully erosion and sediment delivery to streams. Cross road drains will be constructed at approximately 75 ft spacing intervals and these cross road drains will direct road surface runoff off the road onto stable hillslope locations.

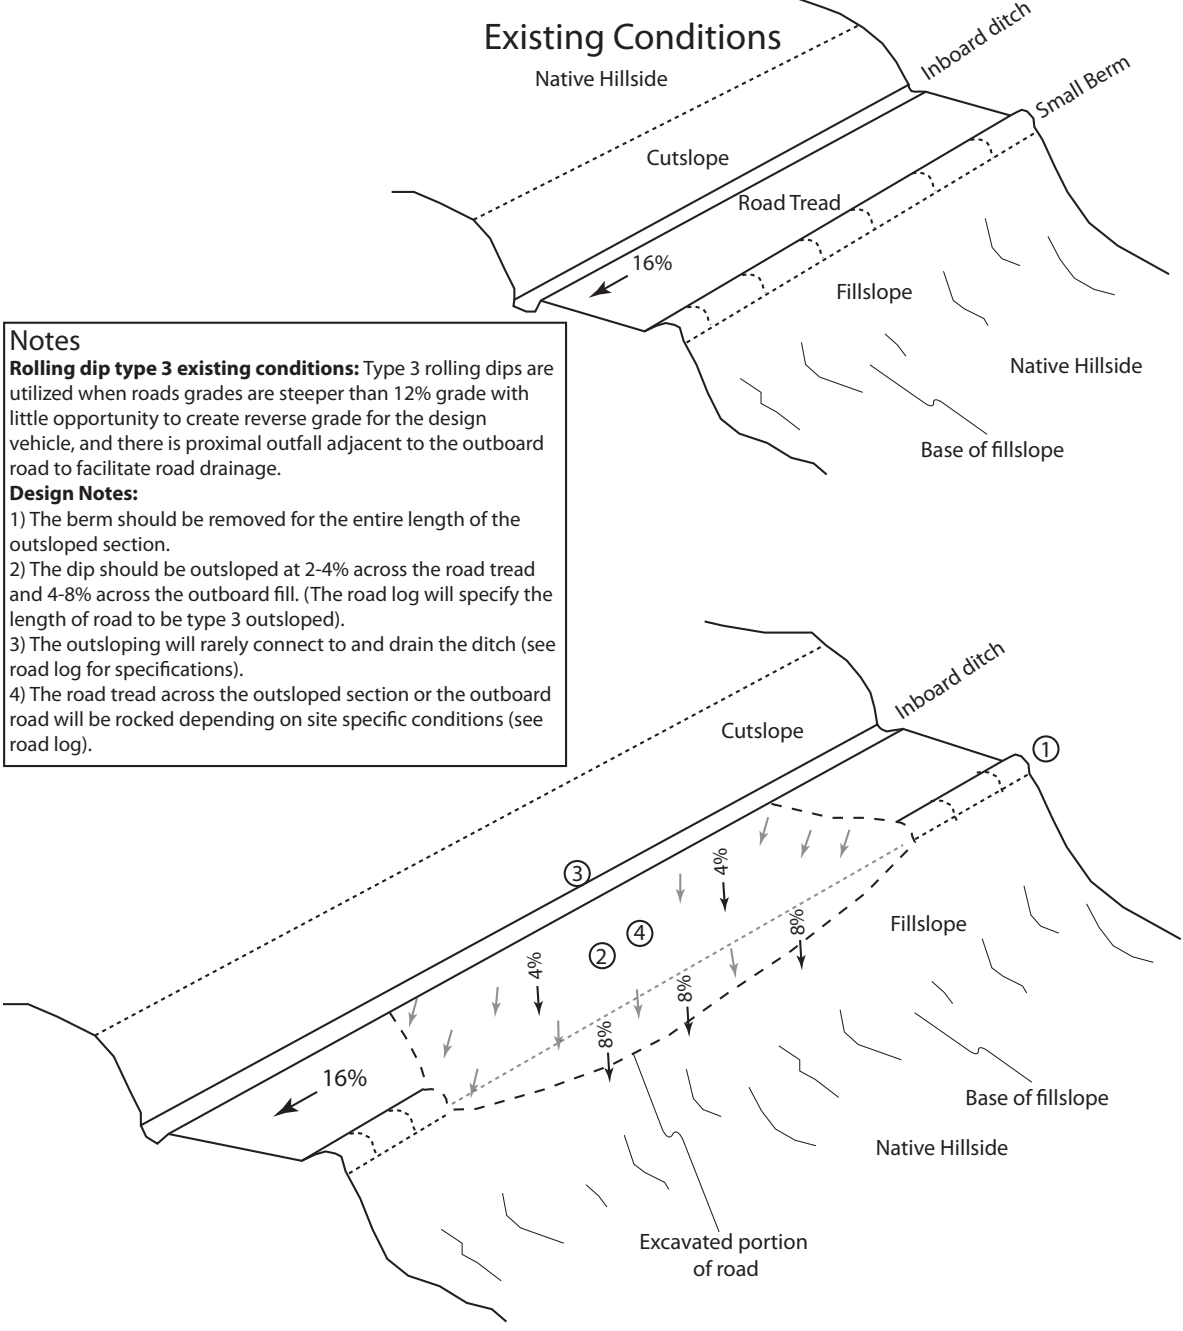
### Type 3 Rolling Dip Construction (steep slope outslope)

**Notes**  
**Rolling dip type 3 existing conditions:** Type 3 rolling dips are utilized when roads grades are steeper than 12% grade with little opportunity to create reverse grade for the design vehicle, and there is proximal outfall adjacent to the outboard road to facilitate road drainage.  
**Design Notes:**  
 1) The berm should be removed for the entire length of the outsloped section.  
 2) The dip should be outsloped at 2-4% across the road tread and 4-8% across the outboard fill. (The road log will specify the length of road to be type 3 outsloped).  
 3) The outsloping will rarely connect to and drain the ditch (see road log for specifications).  
 4) The road tread across the outsloped section or the outboard road will be rocked depending on site specific conditions (see road log).

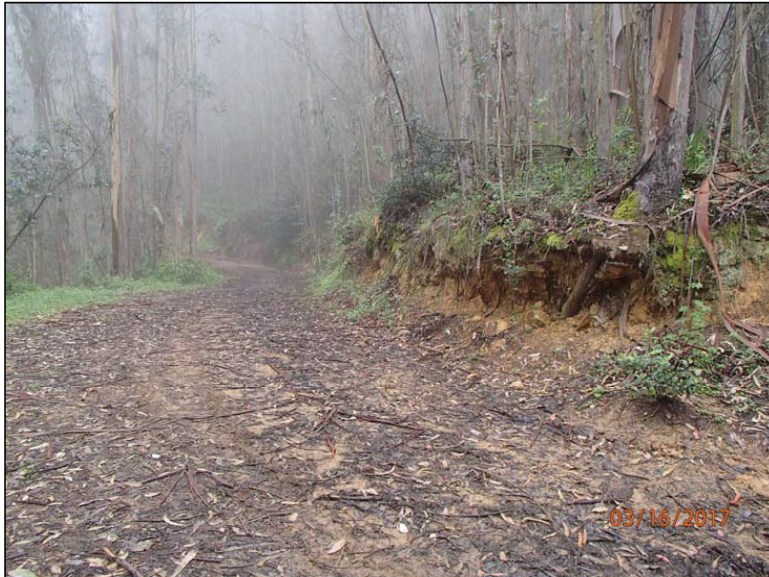
**Photo 1 (Dolphine Fire Road):** View of the existing road conditions of the native surfaced Dolphine Fire Road near the road intersection with the Middle Ridge Fire Road.

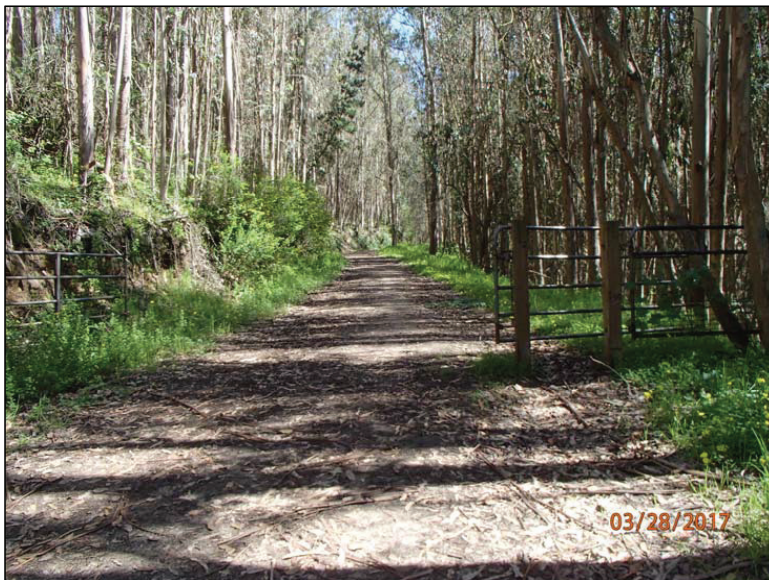
**Photo 2 (Miranda East Fire Road):** View of the existing road conditions on the Miranda East Fire Road at Gate 4 as shown on Map 2.

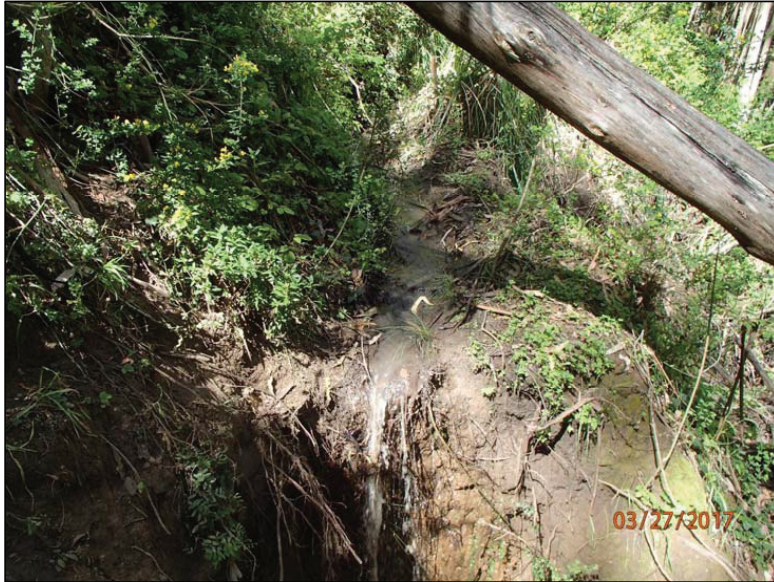
**Photo 7 (Site #4):** View of a road fill failure caused by diverted pond outflow. This erosion feature is located down the right road from the levee. Note the road prism is completely washed out.

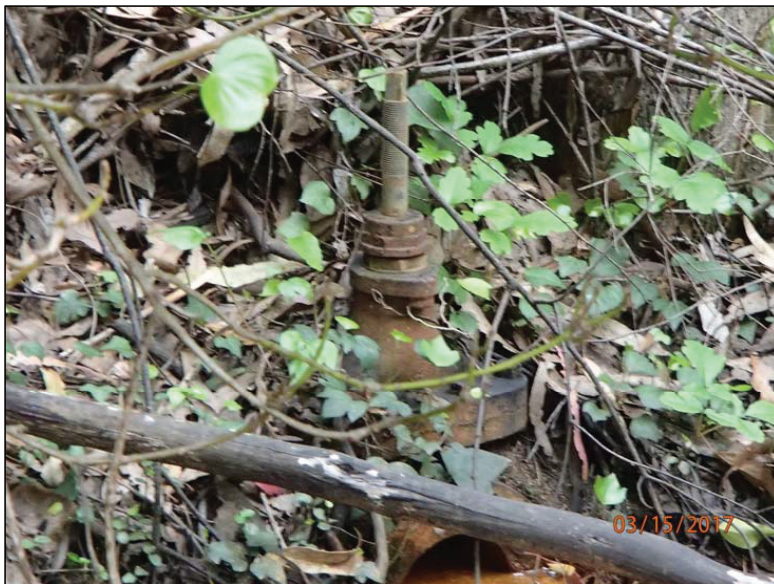
**Photo 8 (Site #4):** View of the seeping drainage valve at base of the dam fillslope in the axis of the valley downstream of pond.

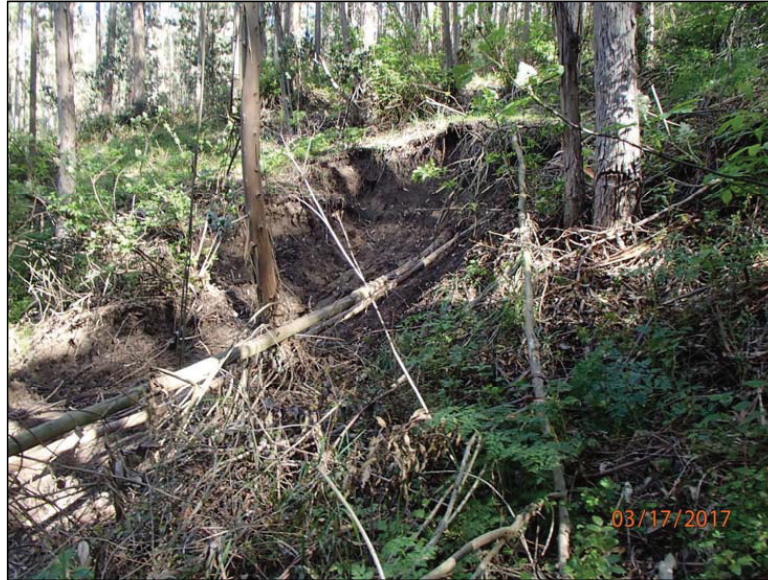
**Photo 11 (Site #19):** View of failing cutbank immediately upslope of the right edge of stream crossing Site #19. This cutbank failure delivers directly to the Class III stream in the axis of the crossing fill crossing.

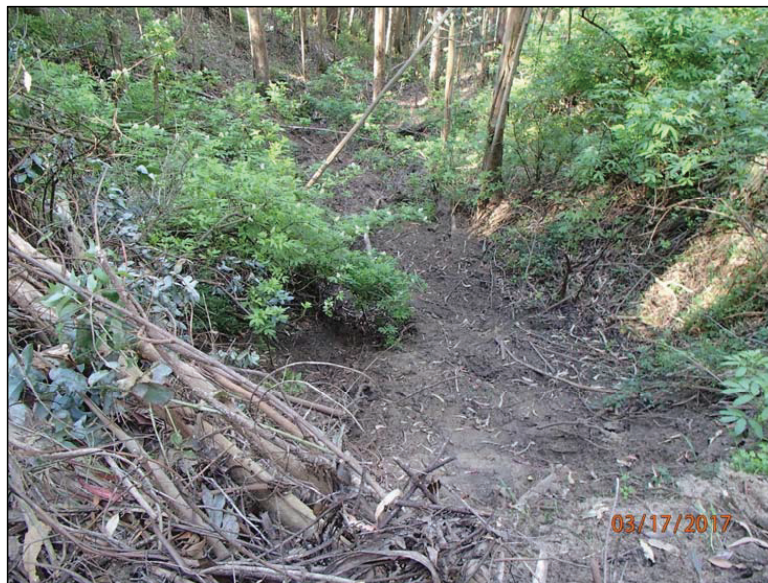
**Photo 12 (Site #19):** View of failing outboard fillslope, looking downslope at the fill failure deposits below the right hingeline of the fill crossing at Site #19. This photo was taken from the outboard edge of the road.

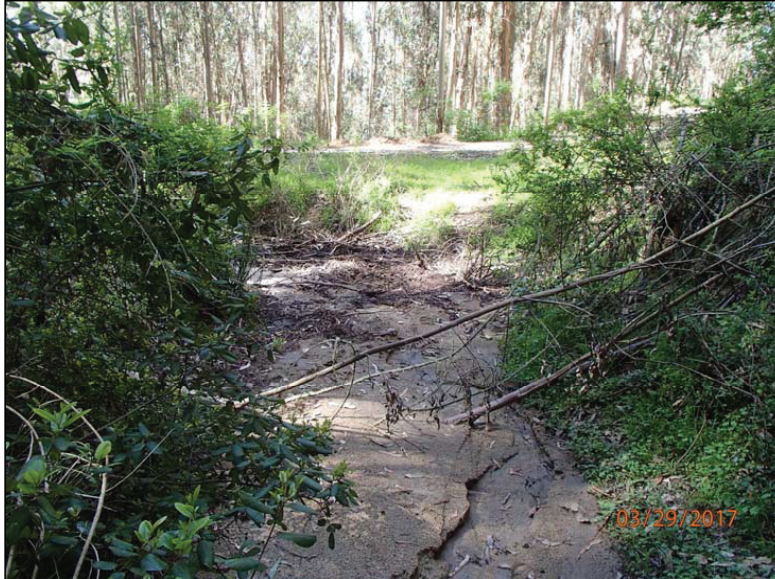
**Photo 13 (Site #39):** View looking downstream from the upstream extent of the of the failing stream crossing. Note the recently deposited sediments that have plugged the culvert inlets. The sediment is causing the stream flow to divert down the left road which is inducing a delivering fill failure.

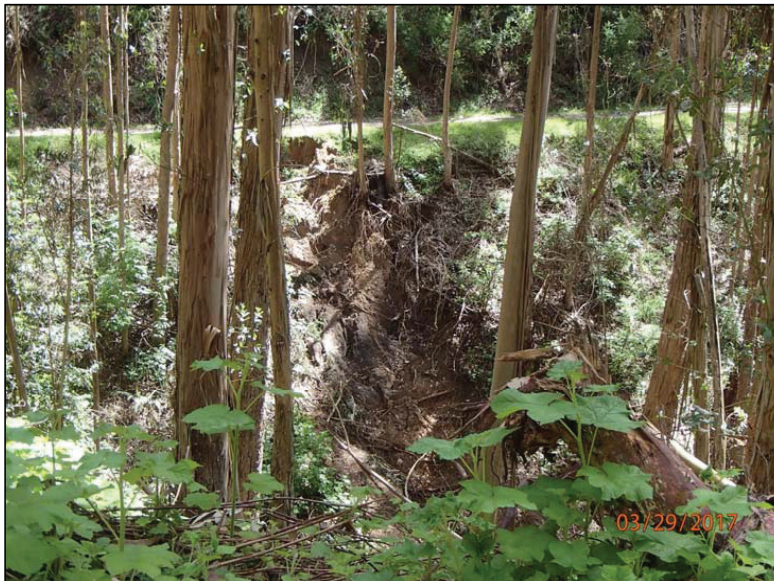
**Photo 14 (Site #39):** View of an outboard fill failure to the left of the stream crossing. The fill failure was induced by the diverted streamflow from the plugged stream crossing at Site #39 and excessive concentrated road surface runoff.

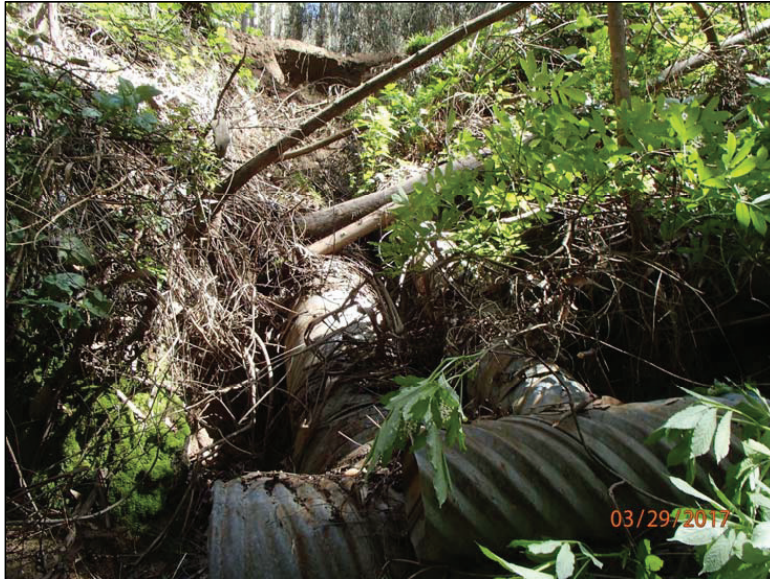
**Photo 15 (Site #39):** View looking upstream at the failing outboard fillslope of this plugged stream crossing. The photo was taken standing approximately 8ft downstream of the culvert outlets.

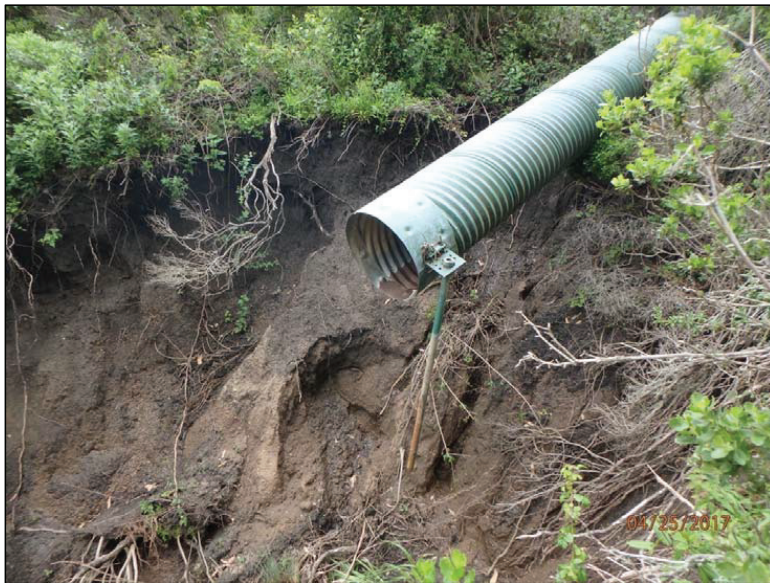
**Photo 16 (Site #40):** View of a section of disconnected culvert downspout at the top of an actively migrating headcut and gully below the paved Private Drive at Site #40. Oxidation exposed on the stake is indicative of the previous depth of burial prior to the episodic hillslope failure.

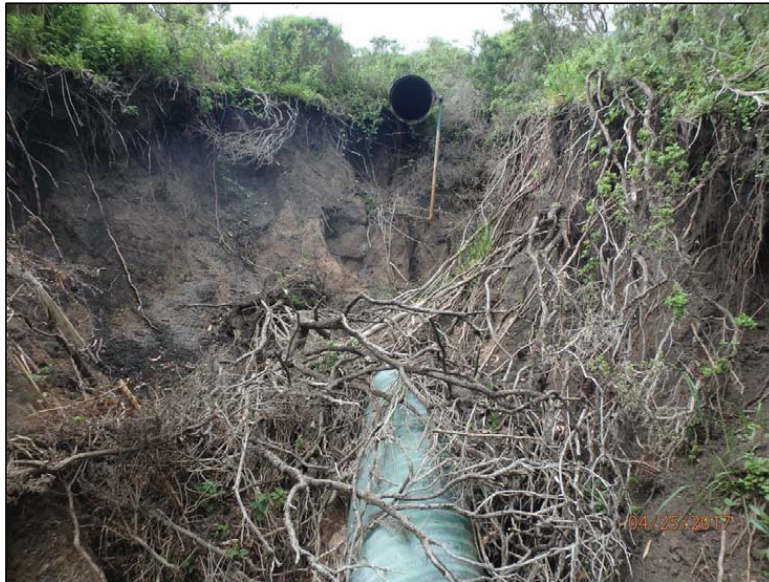
**Photo 17 (Site #40):** View looking upslope at the same disconnected downspout and active erosion as shown in the previous photo. The photo was taken from the base of the gully downslope of the headcut standing on top of one of the failed sections of culvert.

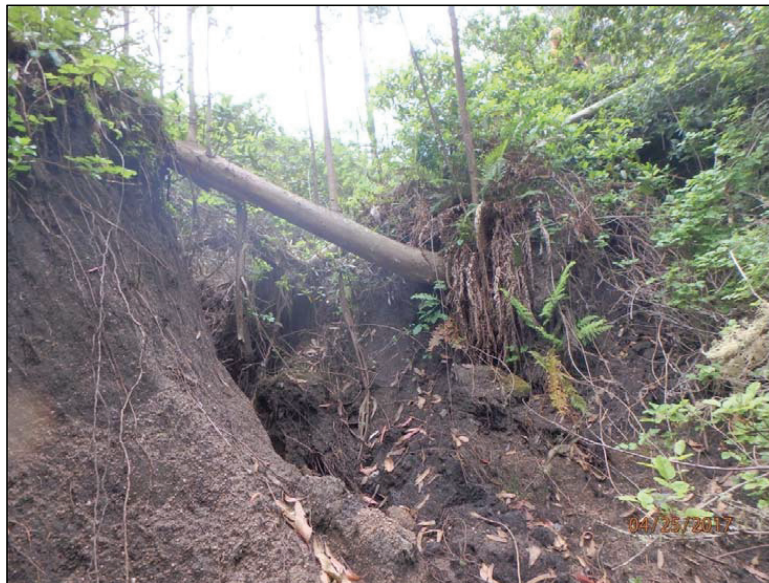
**Photo 18 (Site #40):** View of active hillslope gully below Site #40 looking upstream. This photo was taken from the edge of the tree-line near the headwaters of a small Class III stream that drains to Site #16 downstream. The gully is conveying sediment from the gully erosion upslope to the Class III stream.

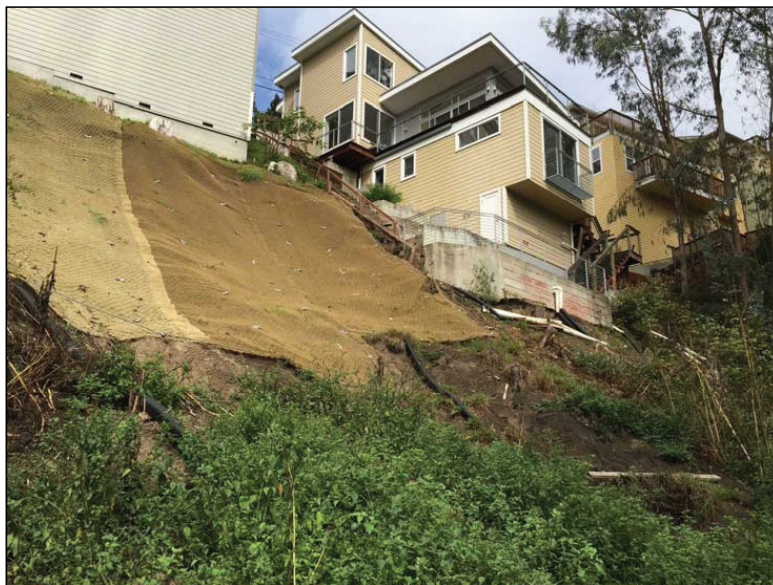
**Photo 20 (Site #41):** View of a hillslope failure and undermined residences upstream from Site #41. This area upslope extent of AOC 4 as discussed in the text of the report. This photo was taken from the outboard edge of the Fire Break Road upslope from the Upper Pond Legacy Road as shown on Map 2.

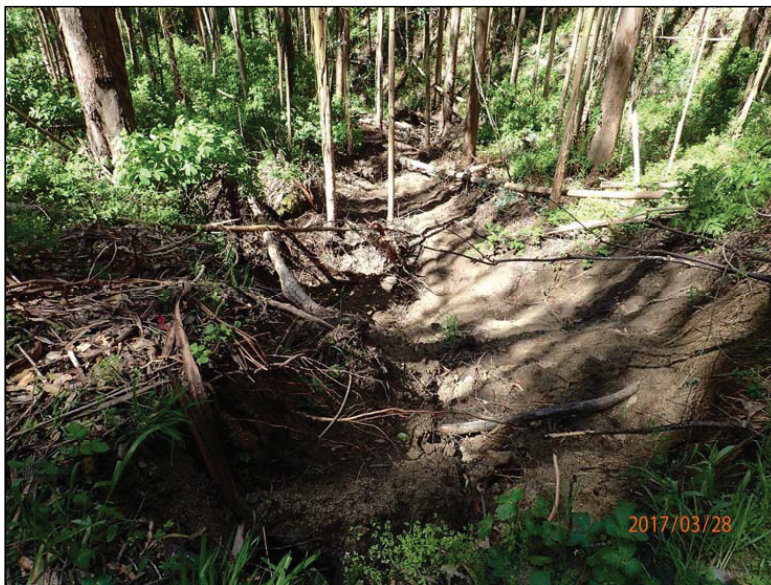
**Photo 26 (Site #31):** View of an outboard fill failure at Site #31 on the Vista Point Trail. Concentrated road run off had saturated the steep outboard fill and subsequently destabilized the fillslope leading to failure.

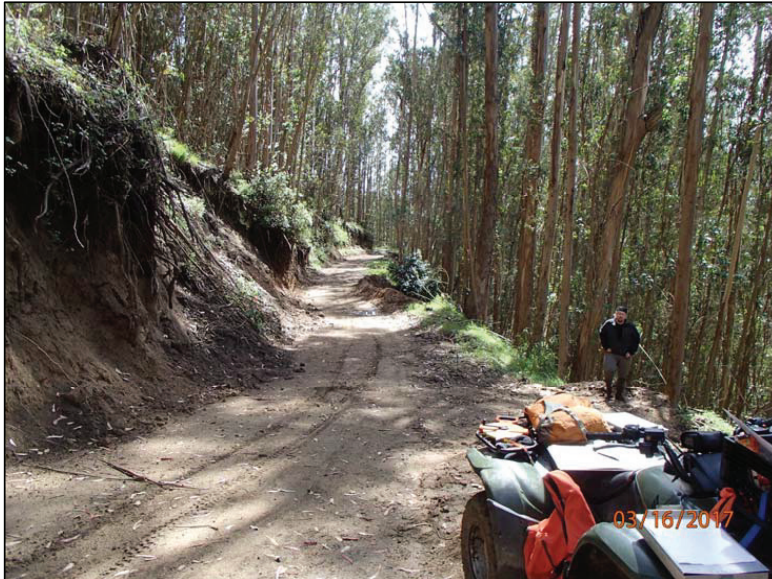
**Photo 29 (Site #11):** View of the hydrologically connected left road approach to landslide Site #11. Long reaches of concentrated road runoff have eroded a gully down the outboard fillslope and induced a failure.

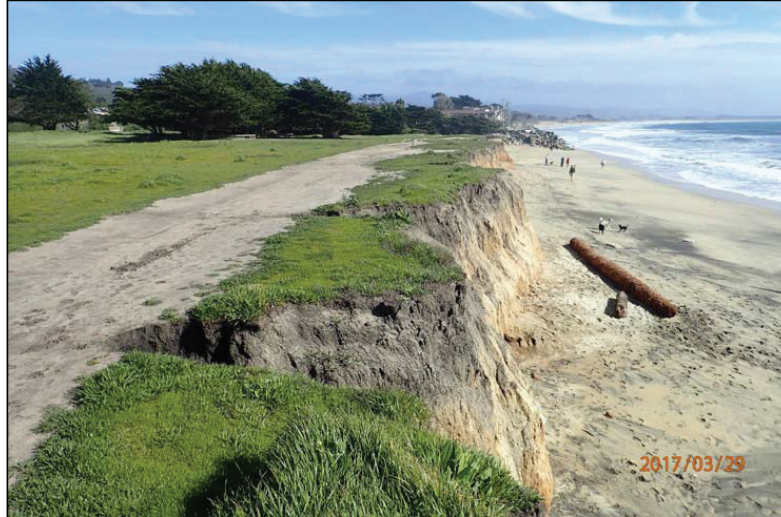
**Photo 30 (Coastal Bluff Trail):** View of bluff retreat looking south along unpaved coastal trail. The gullies located along the wave cut bluffs are exacerbated by concentrated runoff from the trail and upslope marine terrace meadows.

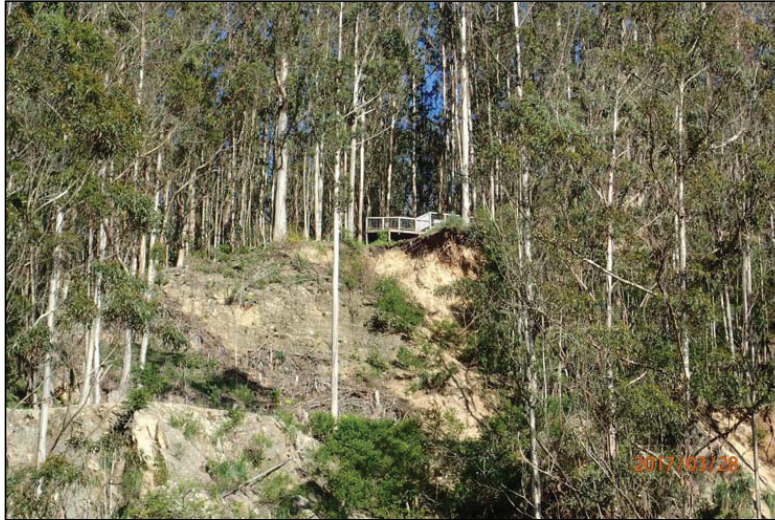
**Photo 33 (Lookout Vista):** View of the lookout deck and failing hillslope below the outermost footing. This photo was taken looking upslope from the base of the quarry floor.

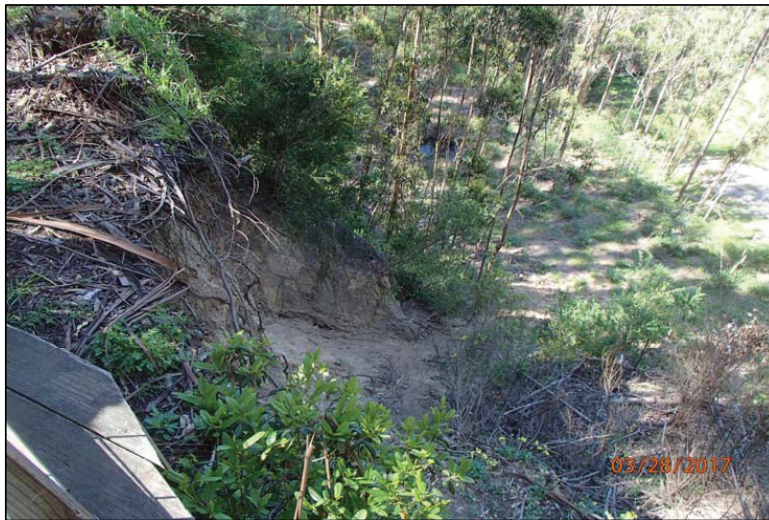
**Photo 34 (Lookout Vista):** View of the failing hillslope below the wooden lookout vista platform. The quarry cutslope is oversteep and is actively failing in multiple locations along the upper edge of the quarry area.
