Assessment of Twenty-Eight (28) Trees  
At Sunrise Senior Living Facility, Redwood City (Proposed)  
(Multiple Residential and Commercial Lots)  
2915 El Camino Real  
Redwood City, California

Walter Levison, Consulting Arborist (WLCA)

5/5/2017

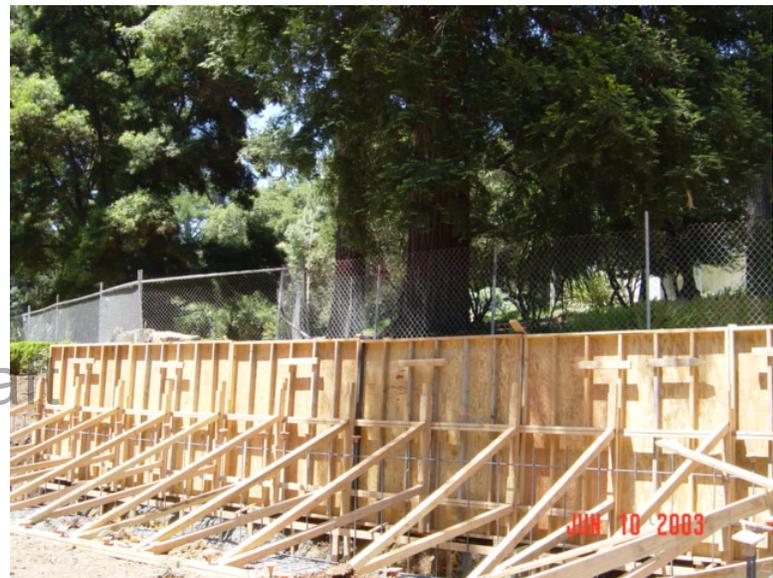
**Oaks #1 through #7** likely exhibit horizontally extended root systems that extend 30 to 40 feet radius (or more) southward and westward, coursing through the old base rock just underneath the existing asphalt parking lot.

It is suggested that the project team consider modification of the proposed building footprint exterior foundation work limit, and the underground parking garage excavation work limit which coincides exactly with the building exterior. The modification suggested is a push to the south and/or west to allow for better lateral offset distance between the oaks' root systems and the excavation cut which will destroy 100% of all lateral woody and absorbing root mass at that distance.

**A suggested minimum distance is 25 to 30 feet from excavation cut to tree trunks.**

Also note that an “**OSHA layback cut**”, often used during deep excavation for new underground parking garages as a safety device that continues a slope cut away from the vertical cut area, is **suggested to be eliminated** (if proposed) for this project, as it would cause severe root damage to the oaks being preserved and protected to the north and east of the building footprint.

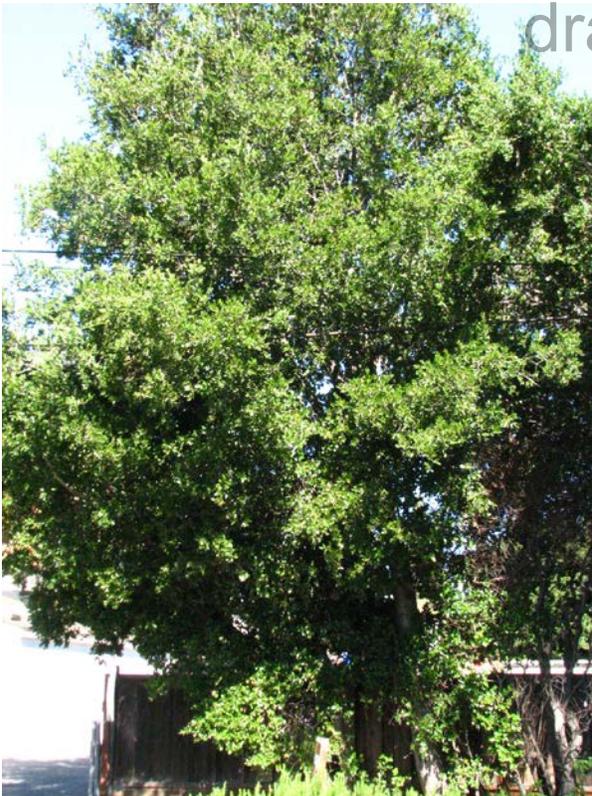
13, 14

North  
view  
of  
oaks  
10, 11,  
12, 13,  
& 14  
extend  
-ed  
south  
and  
west  
into  
the (e)  
lot.
