Cc: Kristen Outten; Amy Ow; robertpellegrine@yahoo.com
Subject: Re: Highland Estates Inspection Report 11/11/2020

Subject: Highland Estates Inspection Report 11/11/2020

**Subject:** Highland Estates Site Inspection 11/11/2020

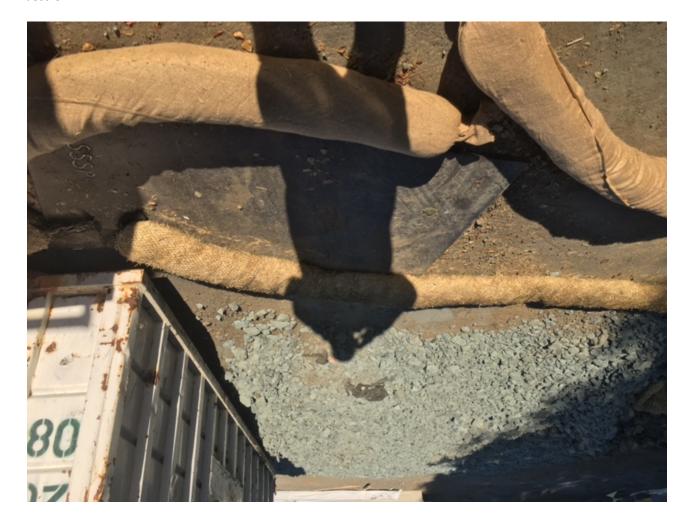
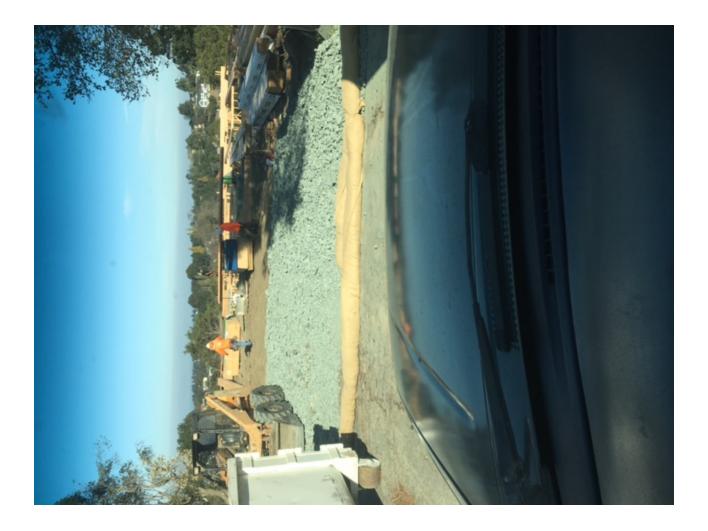
Bob just gave me a call and let me know that they have repaired the stabilized entrances at both Lot 9/10 and Lot 11. Bob sent me the attached photos confirming that this repair has been made.

Thanks for the photos. I spoke with Bob just now; he will fix this today and tomorrow. Aggregate is both inadequate and blocked on Lot 11 due to the placement of the debris box, so it looks like trucks are driving over the dirt part resulting in dirt tracking into the street. I told him that site maintenance over all is low where trash and construction materials need to be picked up at the front of the lots, especially in the area of the missing inlet protection.
